## CLARK FIRE EXPERT DISCLOSURE REPORT

**WILLIAM JEROME RUTH, INDIVIDUALLY,  
AND AS WRONGFUL DEATH REPRESENTATIVE OF  
THE ESTATE OF CYNTHIA SHOOK RUTH**

**UNITED STATES DISTRICT COURT  
FOR THE DISTRICT OF WYOMING**

**CIVIL ACTION NO.: 22-CV-230**

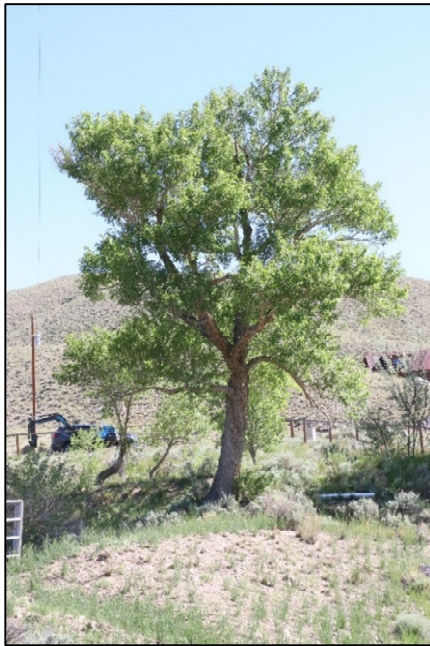
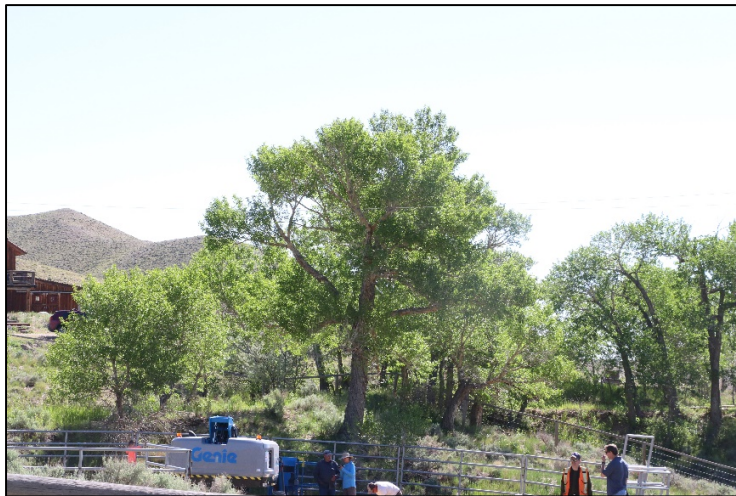
The tree that would eventually come into contact with BEC's distribution line was located within the camp property on the west side of the grove of trees that grew along the south side of the irrigation ditch. The tree was a cottonwood and was about 35 feet tall with a crown of about 35 feet in diameter. For the purposes of clarity, this report will refer to this tree as the "subject tree."

**Figure 4 – Subject tree looking north.**

**Figure 5 – Subject tree looking east.**

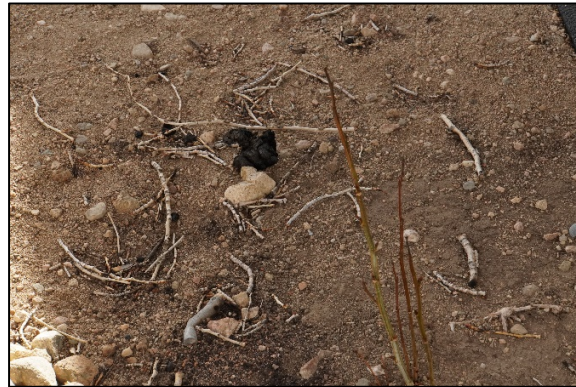
**Photograph 5 - "DSC06116" Taken by IRIS on November 18, 2023, showing twigs with small areas of burning.**

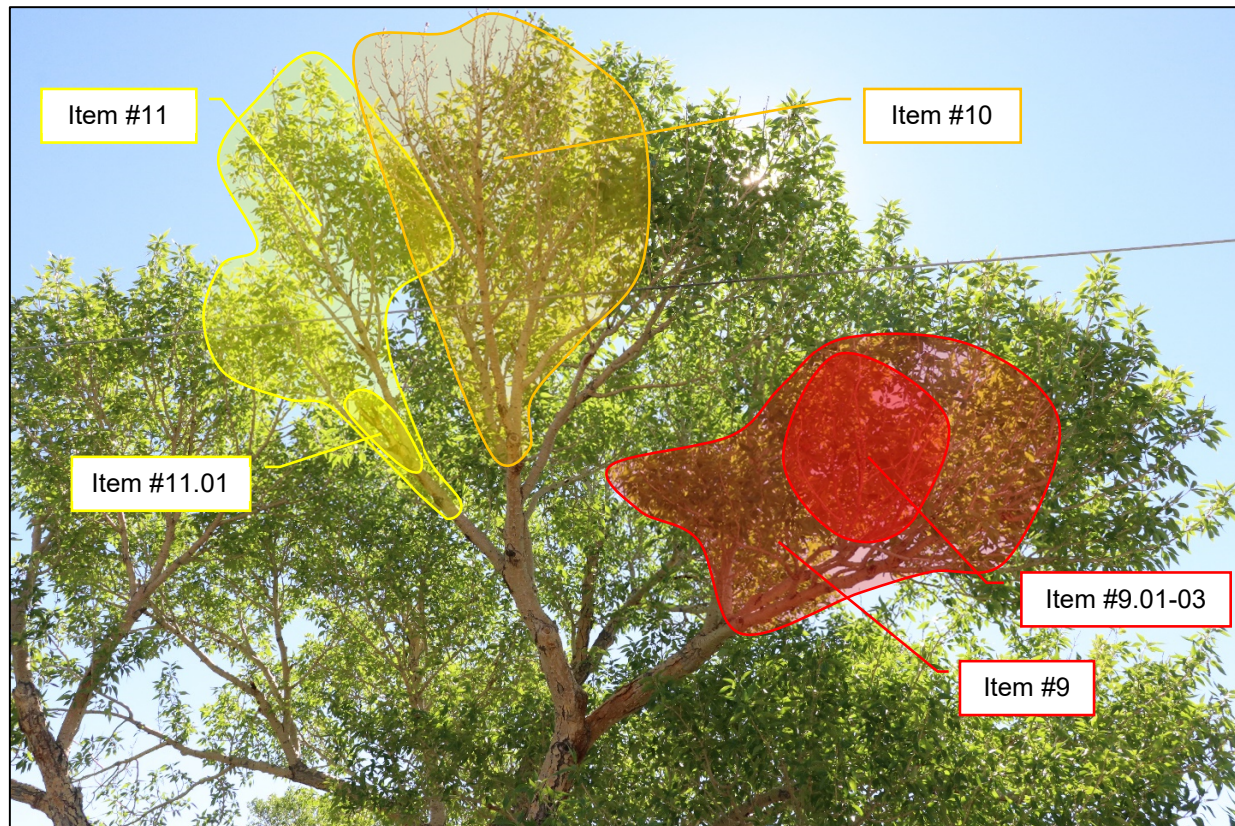
7. Limbs of interest were harvested from the subject tree. These limbs were harvested generally from south to north since BEC personnel, who were performing the harvesting, had set the bucket truck to the south of the tree. Figure 9 shows the location of these branches prior to their harvesting.

**Figure 9 - Crown of subject tree with harvested branches highlighted.<sup>21</sup>**

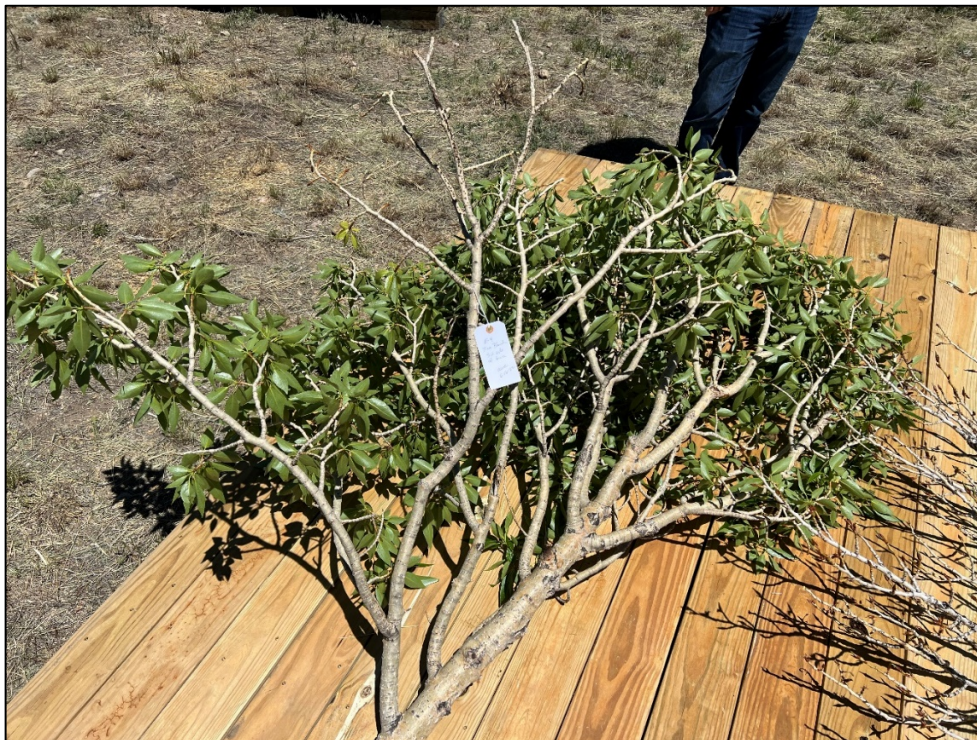
5. A grouping of twigs was found to the south of the broken portion of branch on a limb that would later be collected as Item #9 (E-9). These limbs had patterns of discoloration that manifested in black dots that ran longitudinally along the twigs (See Photograph 8). The distance between these twigs and the phase conductor of the distribution line was measured to be approximately 4 feet and 7 inches (55 inches) with a measuring tape. None of these twigs had sprouted leaves by the time of the inspection.

**Photograph 7 - Evidence Item E-9. Photograph by Eric Black, IMG\_7954.**

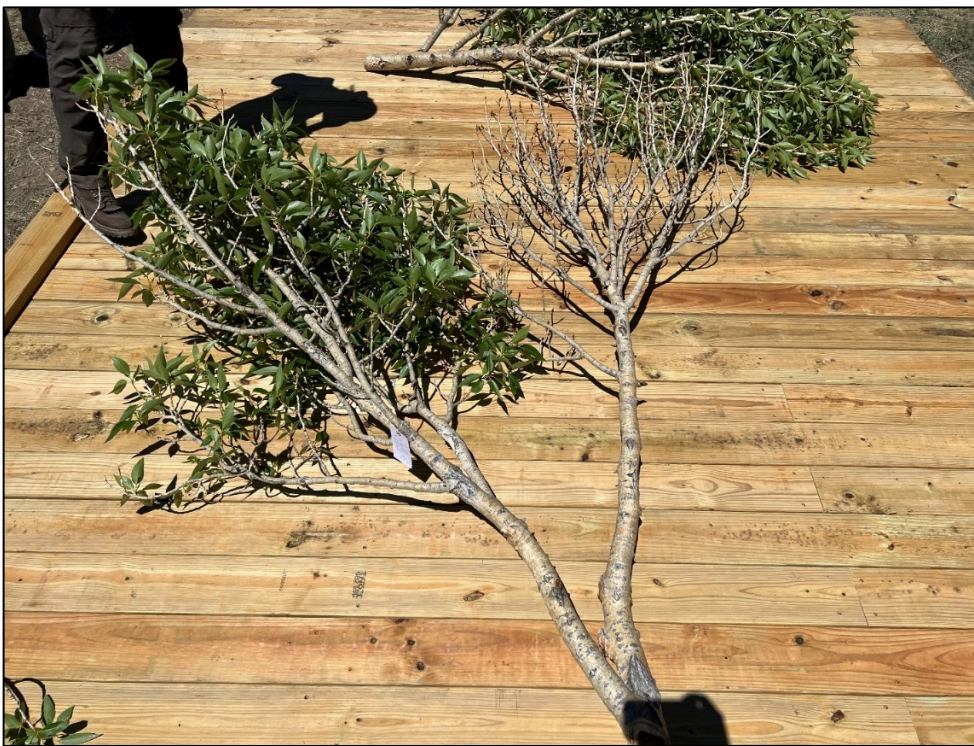
1. The subject tree had sprouted leaves for the season on nearly all of its branches. One branch, shown in Figure 8, that was located on the side of the crown facing the distribution line had not sprouted leaves. This branch would later be collected as part of Item #10 (E-10), as seen in Photograph 9.

**Photograph 9 - Evidence item E-10. Photograph by Eric Black, IMG\_7959.**

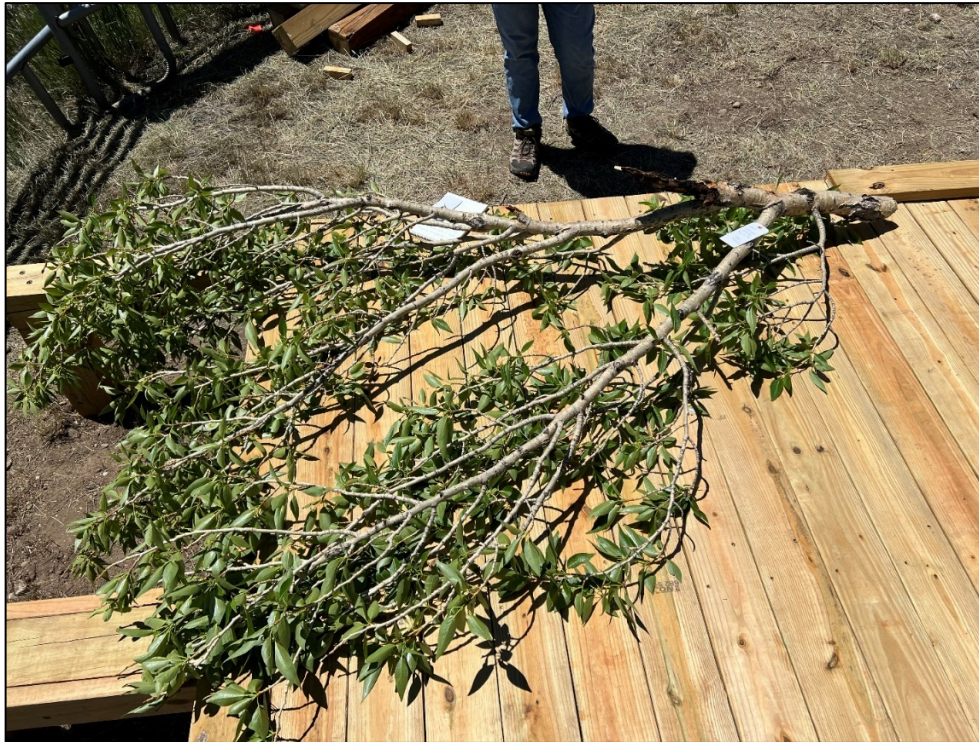
**Photograph 10 - Evidence Item E-11. Eric Black IMG\_7961.**

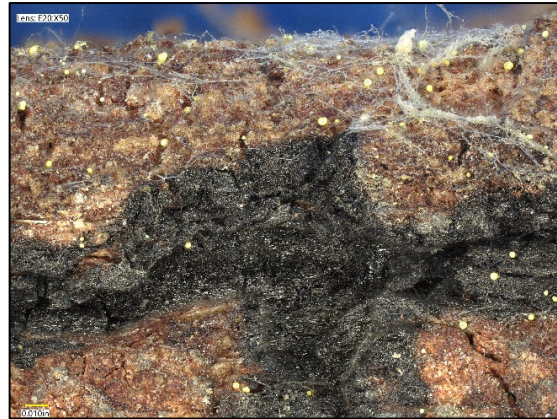
1. Item #9 had a number of small limbs that had patterns of dark spots that ran longitudinally to the limb. These limbs were cut from the branch and marked as Items #9.01, 9.02, and 9.03. The markings were consistent in appearance with markings found on Item #1.
2. In addition to the small circular markings that were found running longitudinally, Item #9.01 showed a linear path of discoloration on its exterior. In addition to the discoloration, the pattern ran as a furrow in the exposed inner bark of the limb. The woody material within the furrow appeared to be pyrolyzed wood.

**Photograph 15 - Microscopy of Item #9.01**

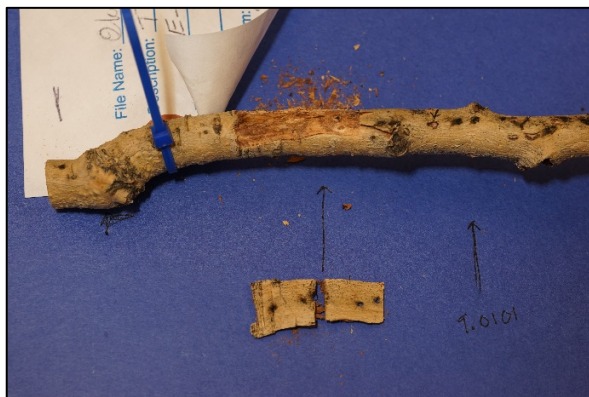
3. Samples of material within the discolored areas of Item #9.01 were taken for SEM imagery and marked as Items #9.0101, 9.0102, and 9.0103.
4. A portion of bark with circular black marks near the basal end of Item #9.01 was cut and peeled away from the interior portions of the limb. With the outer bark peeled away, the black marks on the interior layers of the limb were exposed. The markings appeared as discolored divots that extended deeper into the vascular layer of the limb. See Photograph 16 and Photograph 17.

**Photograph 16 - Item #9.01 with peeled outer bark.**

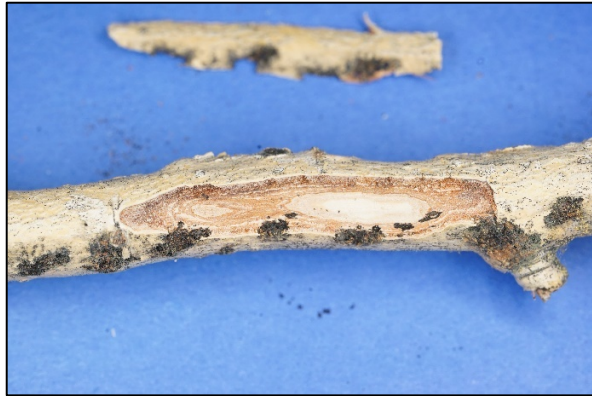
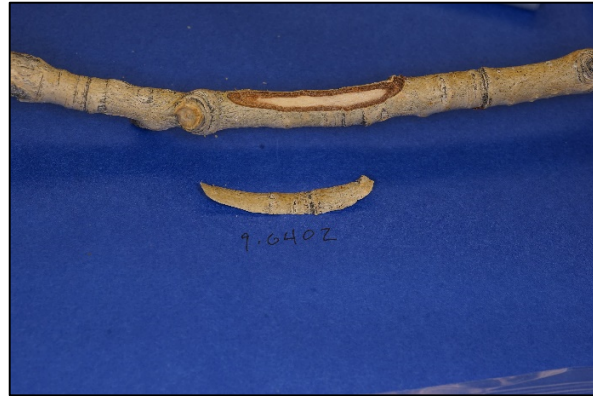
similar markings on limb #9.04 for the purpose of comparison. See Photograph 18 and Photograph 19.

**Photograph 18 - Item #9.01 with a cut exposing the profile of black markings.**

**Photograph 19 - Item #9.04 cut in the same manner as #9.01**

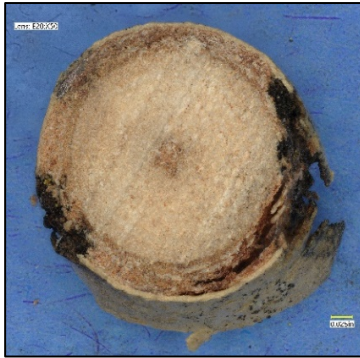
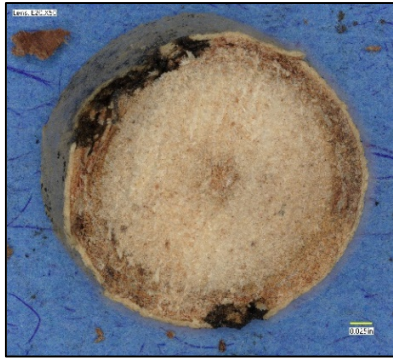
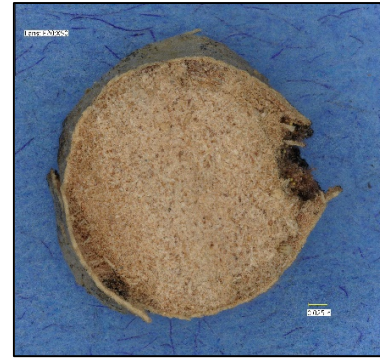
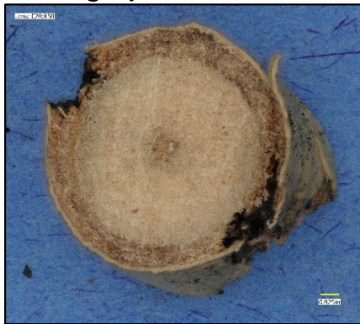
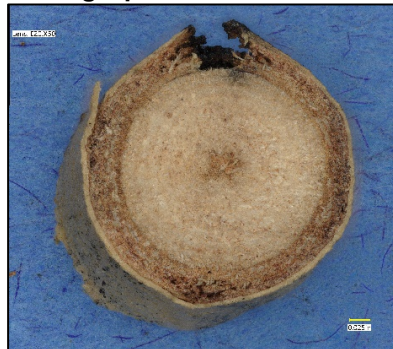
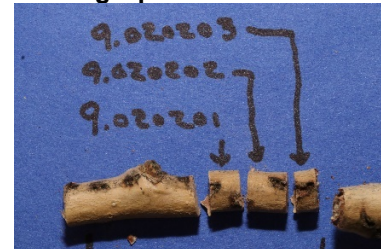
1. Item #9.02 showed areas of discoloration that ran longitudinally to the limb. Two representative sections were chosen due to the uniformity of the of these areas across the two sections. One of the sections (#9.0202) was cut multiple times through selected blackened areas on its length, resulting in Items #9.020201-9.020203. Microscopy of the cut ends showed that most of the areas of discoloration showed penetration and mass loss all the way through the limb's vascular layer. See Photograph 21 through Photograph 26.

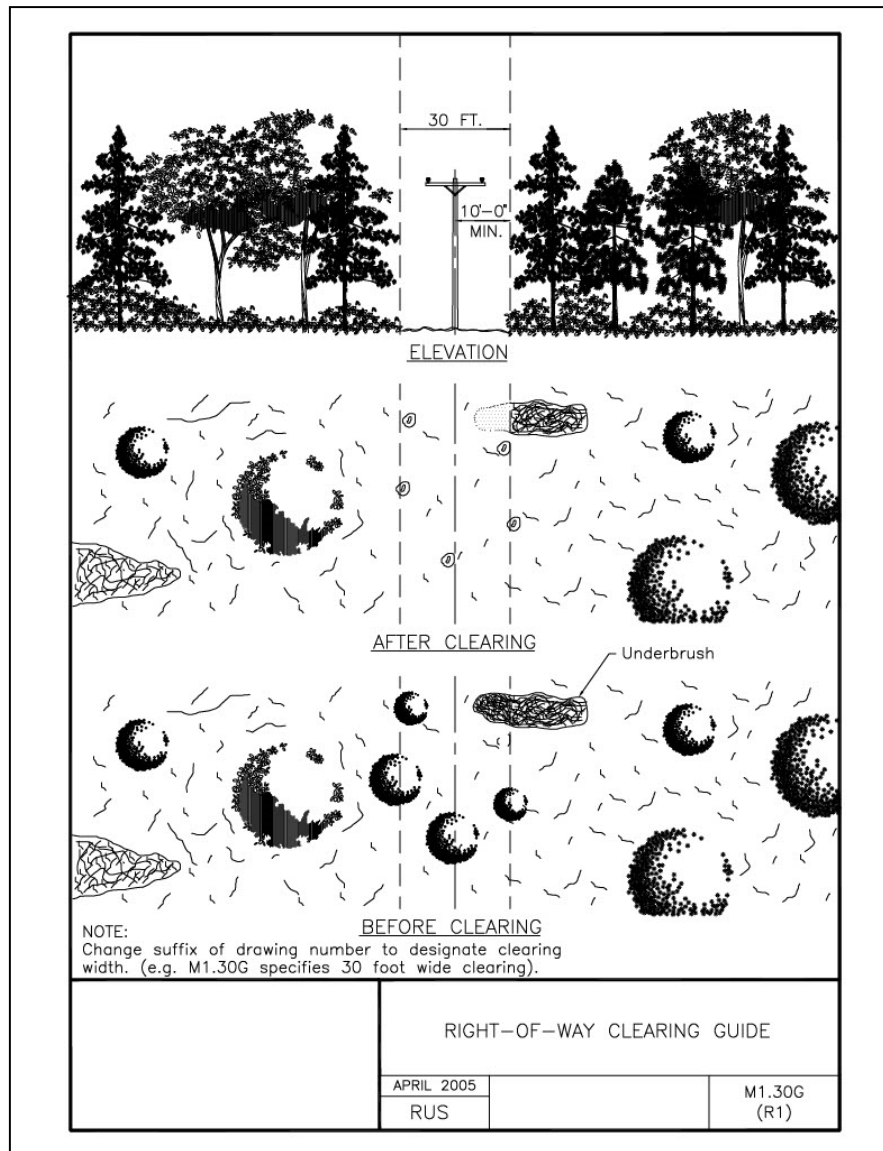
**Figure 11 - Specification M1.30G<sup>27</sup>**

Per BEC's Right-of-Way Clearing Contract, Asplundh was to perform their trimming work in multiple counties in Montana and in Park County in Wyoming. Clark, Wyoming and the Line Creek Tap are located in Park County. Vegetation was to be cleared to maintain a twenty (20) foot wide ROW corridor, with boundaries ten (10) feet to either side of the centerline between utility poles. This corridor was to be maintained from ground level to twelve (12) feet above conductor height.<sup>26</sup> BEC included Specification M1.30G, shown below in Figure 11, as a guide for this work. Specification M1.30G shows the ROW corridor being thirty (30) feet wide; however, it notes that the "30" in the drawing name can be changed to suit the desired width. If BEC had modified the drawing to reflect their desired twenty (20) foot width, the drawing name should have been changed to "M1.20G."

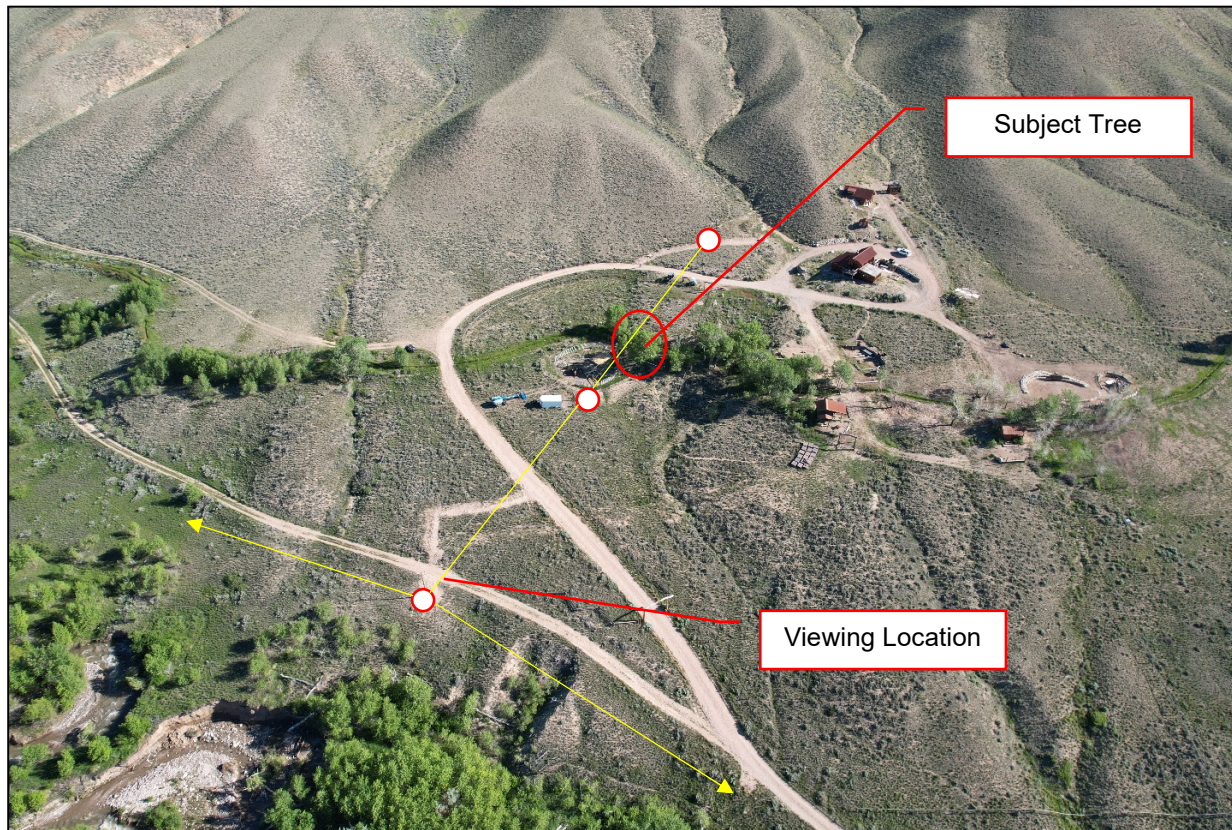
after which time Rowe and Toler agreed that the subject tree was outside the ROW and did not need to be trimmed. In his deposition, Toler stated that the tree was twenty (20) to thirty (30) feet away from the distribution line. He also stated that he was not wearing the prescription glasses that were required for him to drive.

**Figure 12 - Aerial view of the location that the subject tree was assessed from.**

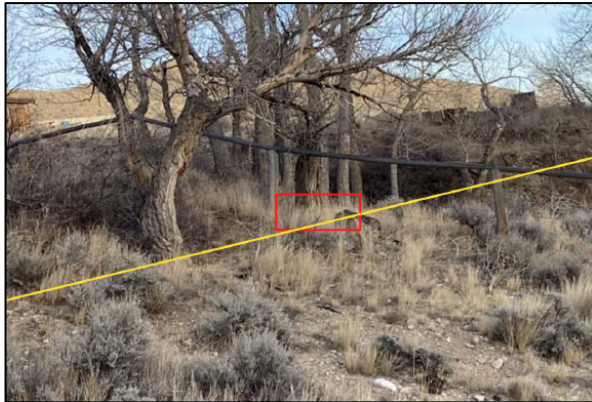
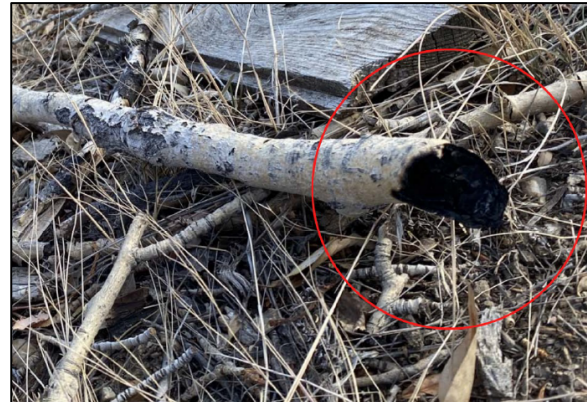
Although Item #1 was found on the ground downwind of the subject tree, the burning that occurred at its base could only have been caused by contact with the distribution line. The branch was found in an area that had no other burning, as shown in Figure 15 and Figure 16. The branch obviously traveled to its location on the ground after it began to burn. Since there were no other signs of burning between E-1 and the crown of the subject tree, it can be determined that E-1 originated at the subject tree. As with Item #11.01, there are no other competent ignition sources available to initiate burning in the crown of the tree other than the nearby distribution line.

**Figure 15 - Excerpt from Ex 14-16-a. The red box shows the general location that Pam Nelson found branch E-1.**

**Figure 16 - Excerpt from Ex 14-17-a showing unburnt material around E-1.**

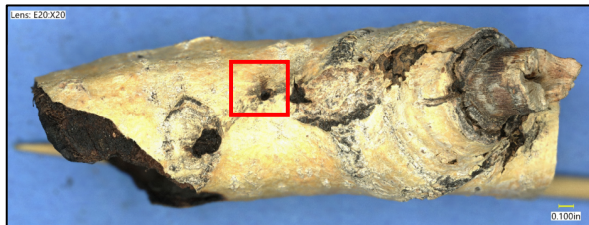
As noted in the observations from the July 27, 2023, evidence inspection, some of the holes found in Item #1 appeared to have pattern of discoloration that extended radially from the perimeter of the hole in the outer bark. Of the four radial patterns that were found on Item #1, each area of discoloration extended from its respective hole in a direction within approximately 45 degrees of the others. This directionality appears to be consistent with the escape of gasses into a uniform wind field. The discoloration may be the deposition of condensed vapors, or it may be the result of hot gasses discoloring the outer bark itself.

**Figure 17 - Composite microscopy of the basal section of Item #1 with a box showing the location of Figure 18**
